QUINNIPIAC RIVER BASIN  
WOODBIDGE, CONNECTICUT

LAKE WATROUS DAM  
CT 00318

PHASE I INSPECTION REPORT  
NATIONAL DAM INSPECTION PROGRAM

AUGUST 1978

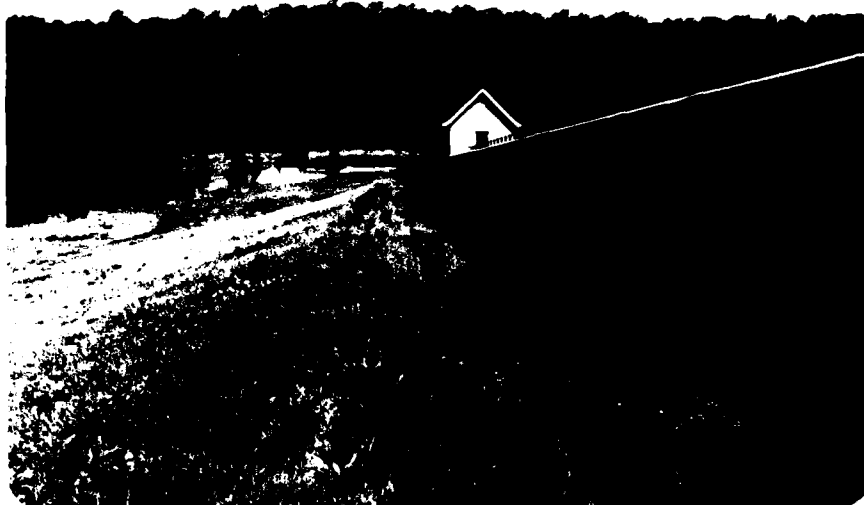
PHOTO NO.1 - General view of downstream face of dam and embankment.
